TERRAIN STABILITY ASSESSMENT

**Big White Ski Resort
Backcountry &
Black Forest Chair Expansion**

Whitefoot Creek

Subject: **Terrain Stability Assessment of
Big White Ski Resort Backcountry and Black Forest Chair Expansion**

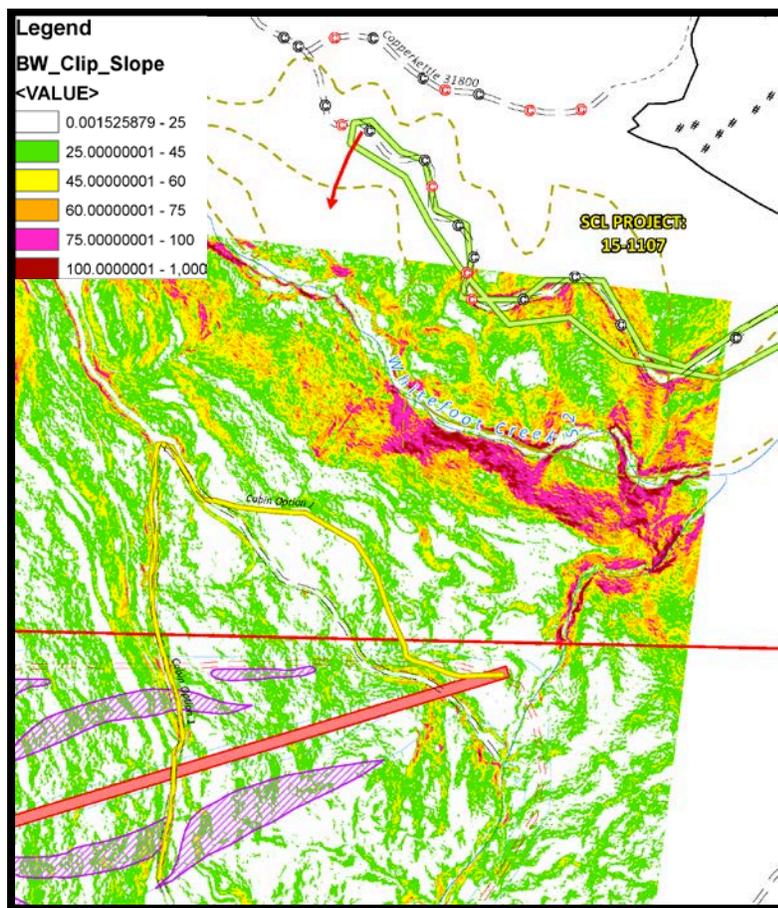
Terrain downslope of existing Spur 2 and prior to the slope break into the Whitefoot Creek gully consists of slightly irregular broken slopes with lateral swales, gullies and local high points. Slope gradients are flat to moderate and typically <25% with infrequent isolated areas up to 45% which are generally <25 m in slope length. A significant portion of this area has been previously harvested.

Image 2: LiDAR slope map of terrain the northeast tip of the proposed development and downslope which was traversed by SCL.

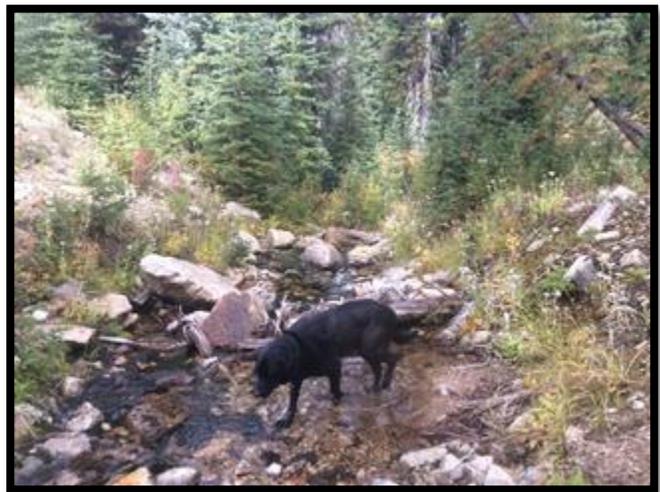
To the east at ~1630 m in elevation, Stream S5-1 is situated within a well-defined gully with sidewalls 5 m to 7 m long and slope gradients of 55%. The channel consists of gravel, cobbles and boulders with a step pool morphology, some woody debris and a channel gradient of 15% (Image 3). Downstream, LiDAR indicates that the gully becomes more incised and the channel gradient increases with loss of elevation transitioning to ~25% to 50% below 1580 m in elevation downstream to the confluence with Whitefoot Creek. A short NCD with a 10% gradient and confined within a gully was observed at 1610

Image 3: Stream S5-1 at 1630 m in elevation.

m elevation to the north of Stream S5-1; it is unknown if it has continuity to the stream. Based on the terrain configuration, the adjacent drainage divide to the west, and the location of the development, it is unlikely that a development-related debris slide would impact the lower reaches of Stream S5-1, which could be susceptible to a debris flow if impacted by a debris slide.
