Big White Ski Resort
MASTER PLAN MODIFICATION
October 2018

On behalf of Big White Ski Resort Ltd. (Big White), Brent Harley and Associates Inc. (BHA) is pleased to submit this Modification to the approved 1999 Big White Ski Resort Master Plan for the development for two new chairlifts, currently referred to as the Black Forest Connector and the Backcountry Chair. The Black Forest Connector and Backcountry chairlifts would be located to the east of the Black Forest Express, within Big White's existing Controlled Recreation Area. Together, these chairlifts represent the full realization of the vision described in the 1999 Master Plan, and the fulfillment of the Controlled Recreation Area's physical potential to offer a world-class alpine skiing experience.

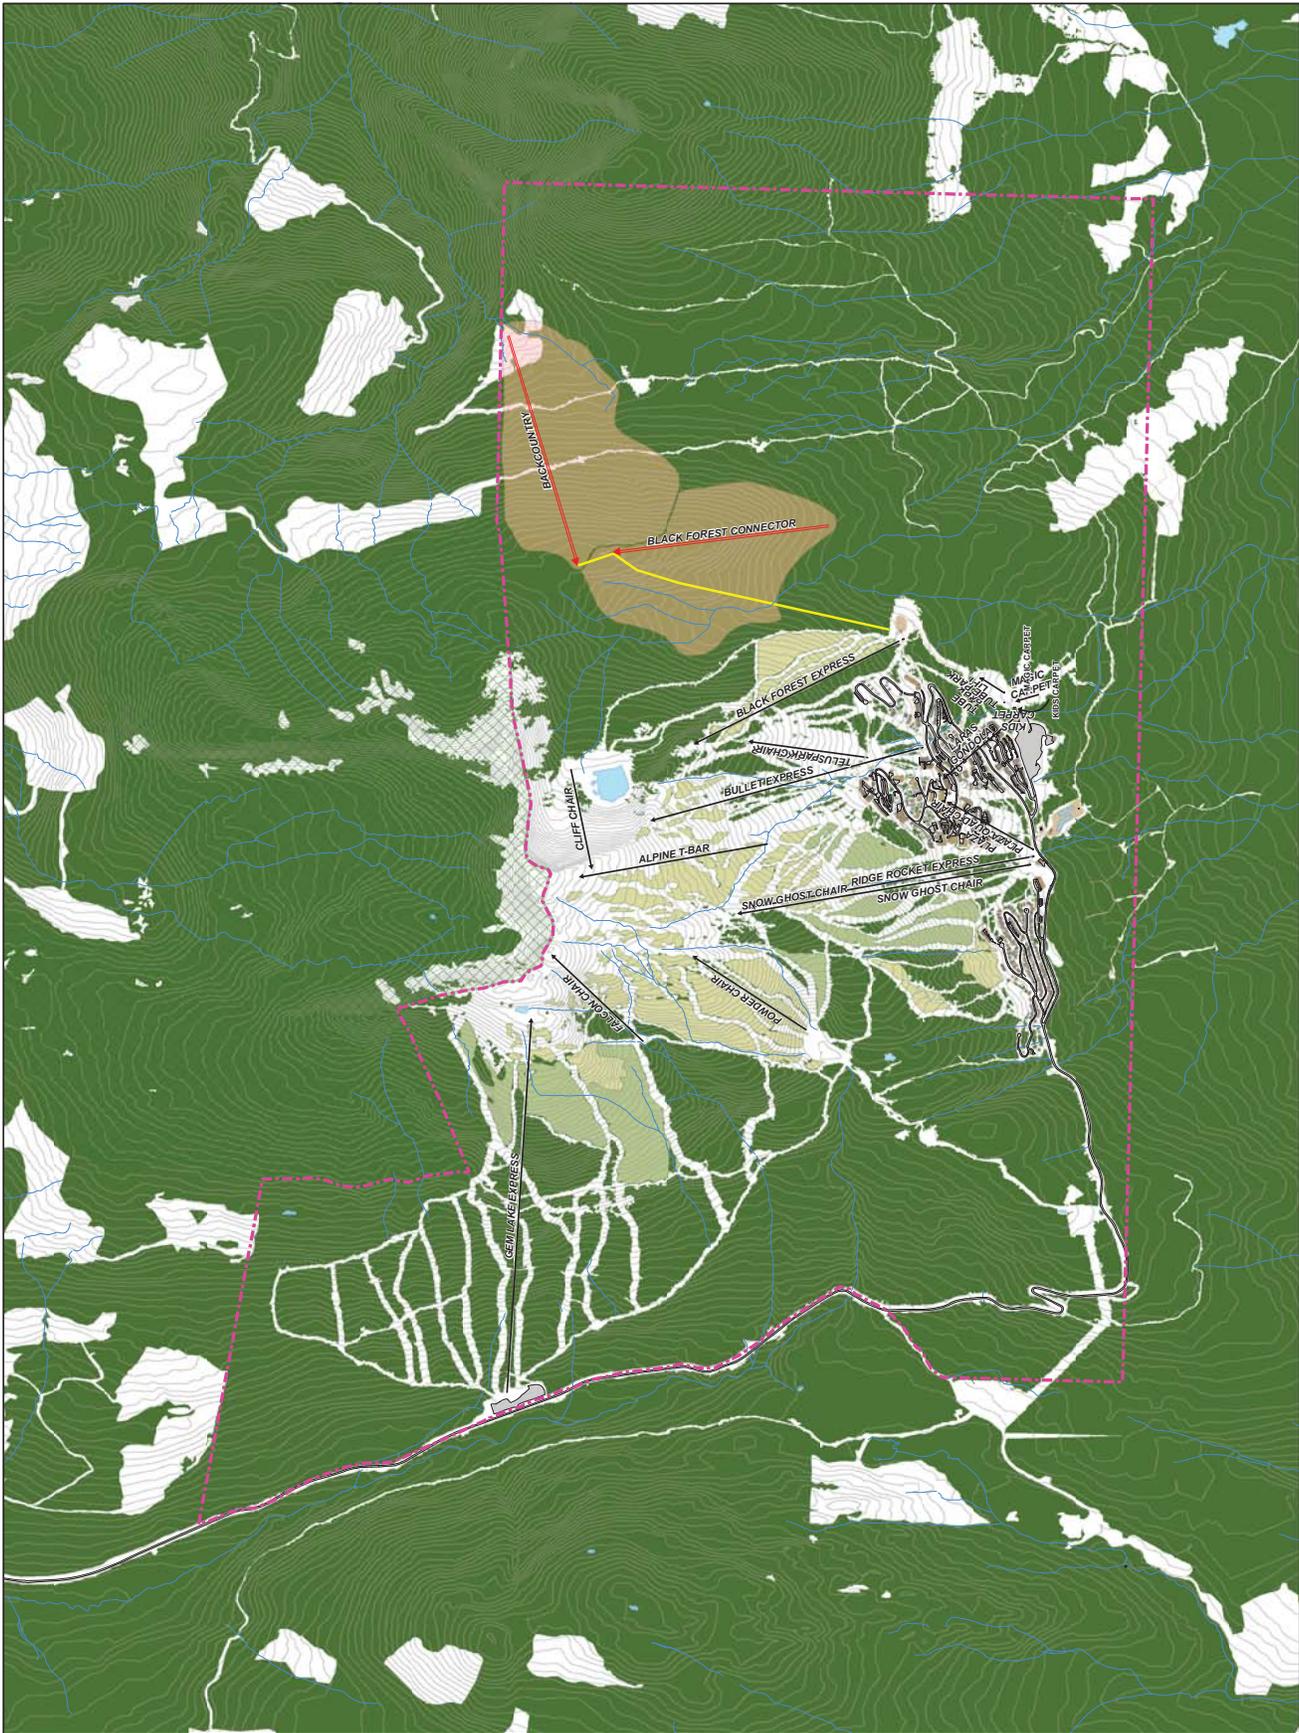
Figure 2.
Black Forest Connector
and Backcountry Chair
Context Map

The 1999 Big White Ski Resort Master Plan described the development of two ski pods (i.e. a chairlift and associated ski terrain) to the west of the Gem Lake Express (Fig. 1, Pods A & C), conditional on a CRA boundary adjustment. These ski pods and the associated Westridge Base Area were not pursued for a variety of reasons. The Black Forest Connector and Backcountry Chair represent the relocation of these approved ski pods to the east of the Black Forest Express, staged from the existing Black Forest Day Lodge (Fig. 2).

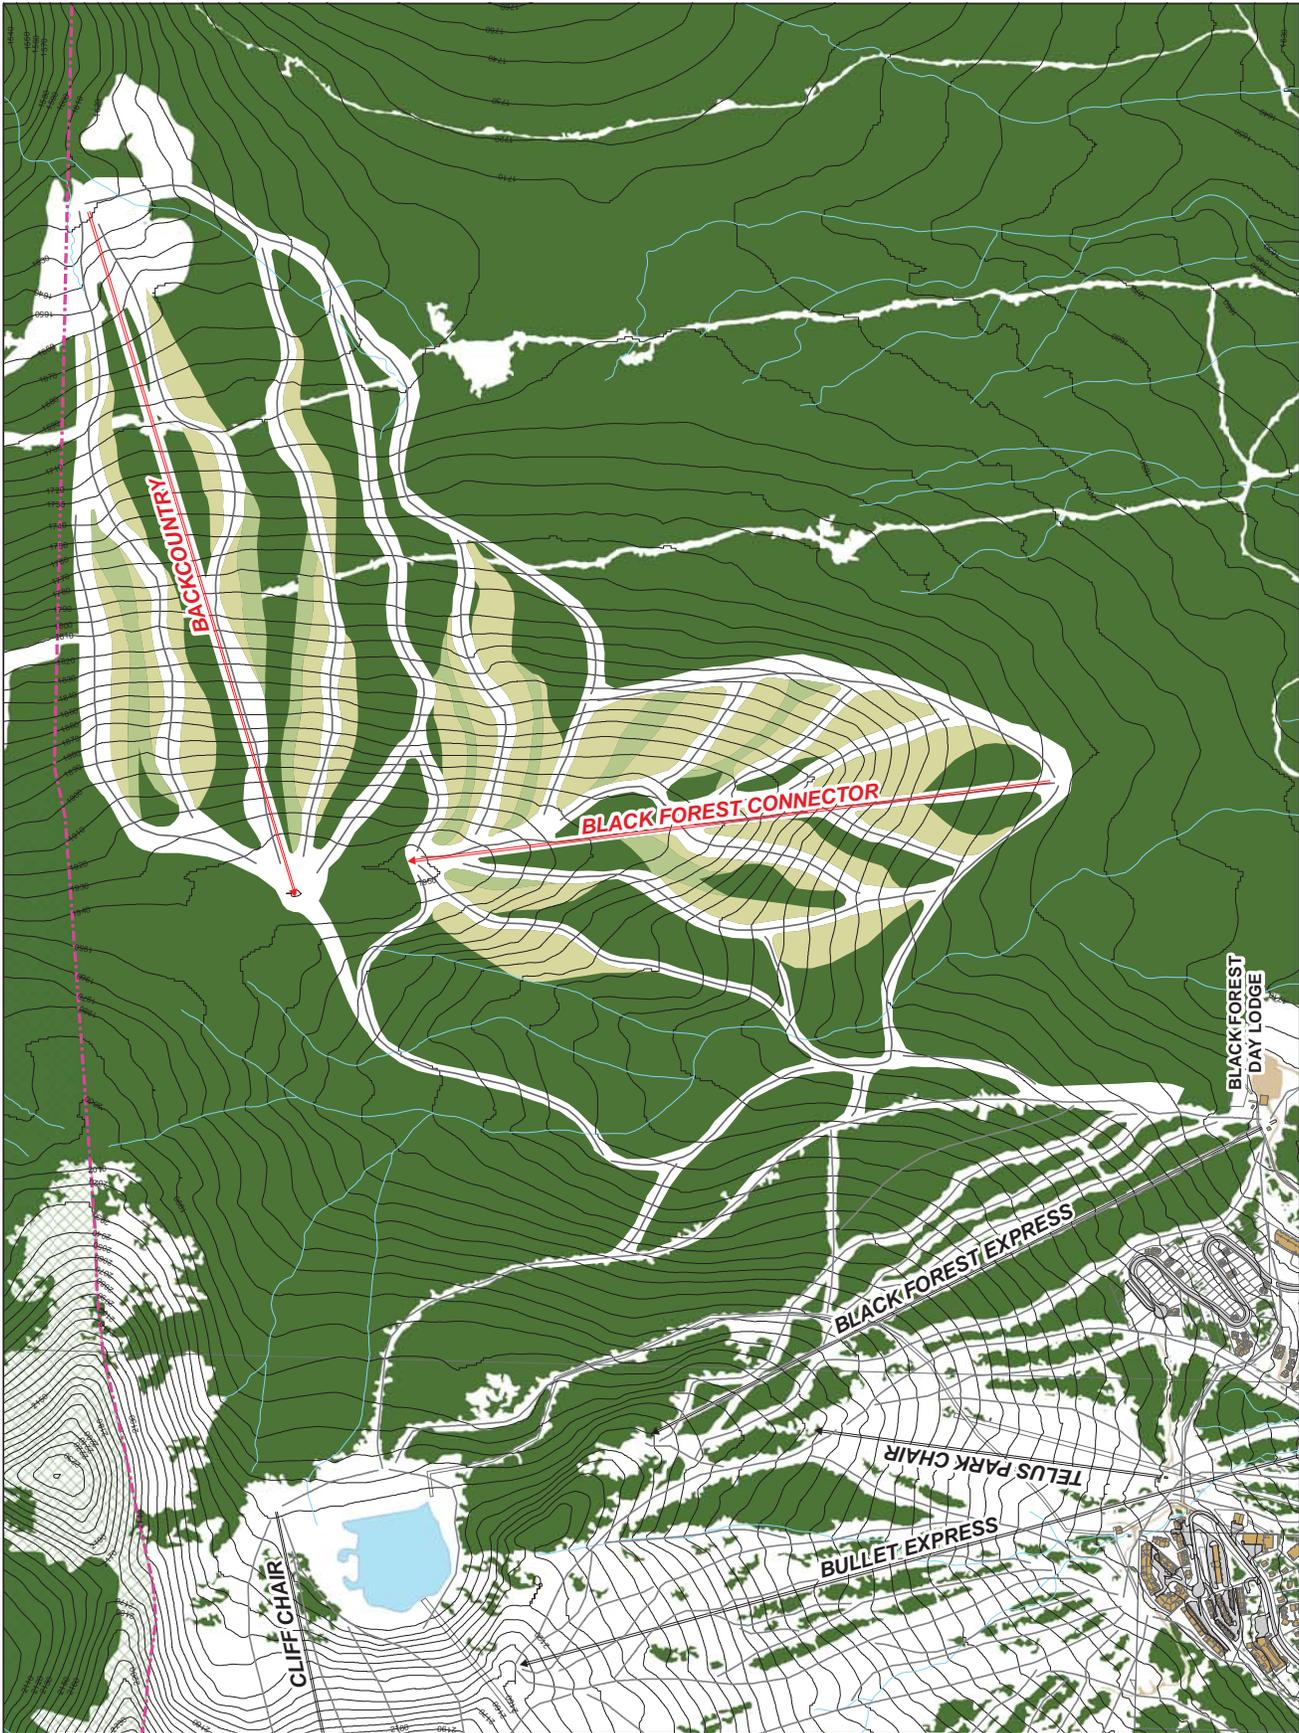
Figure 7.
Black Forest Connector
and Backcountry Chair
Proposed Glading

- Legend**
- Proposed Glading**
 - Thin (5-7m Spacing)
 - Dense (2m Spacing)
 - Proposed Lifts**
 - Proposed Ski Trails**
 - Existing Ski Lifts**
 - Existing Ski Runs**
 - Existing CRA Boundary**
 - Streams**
 - Existing Buildings**
 - Ecological Reserve**

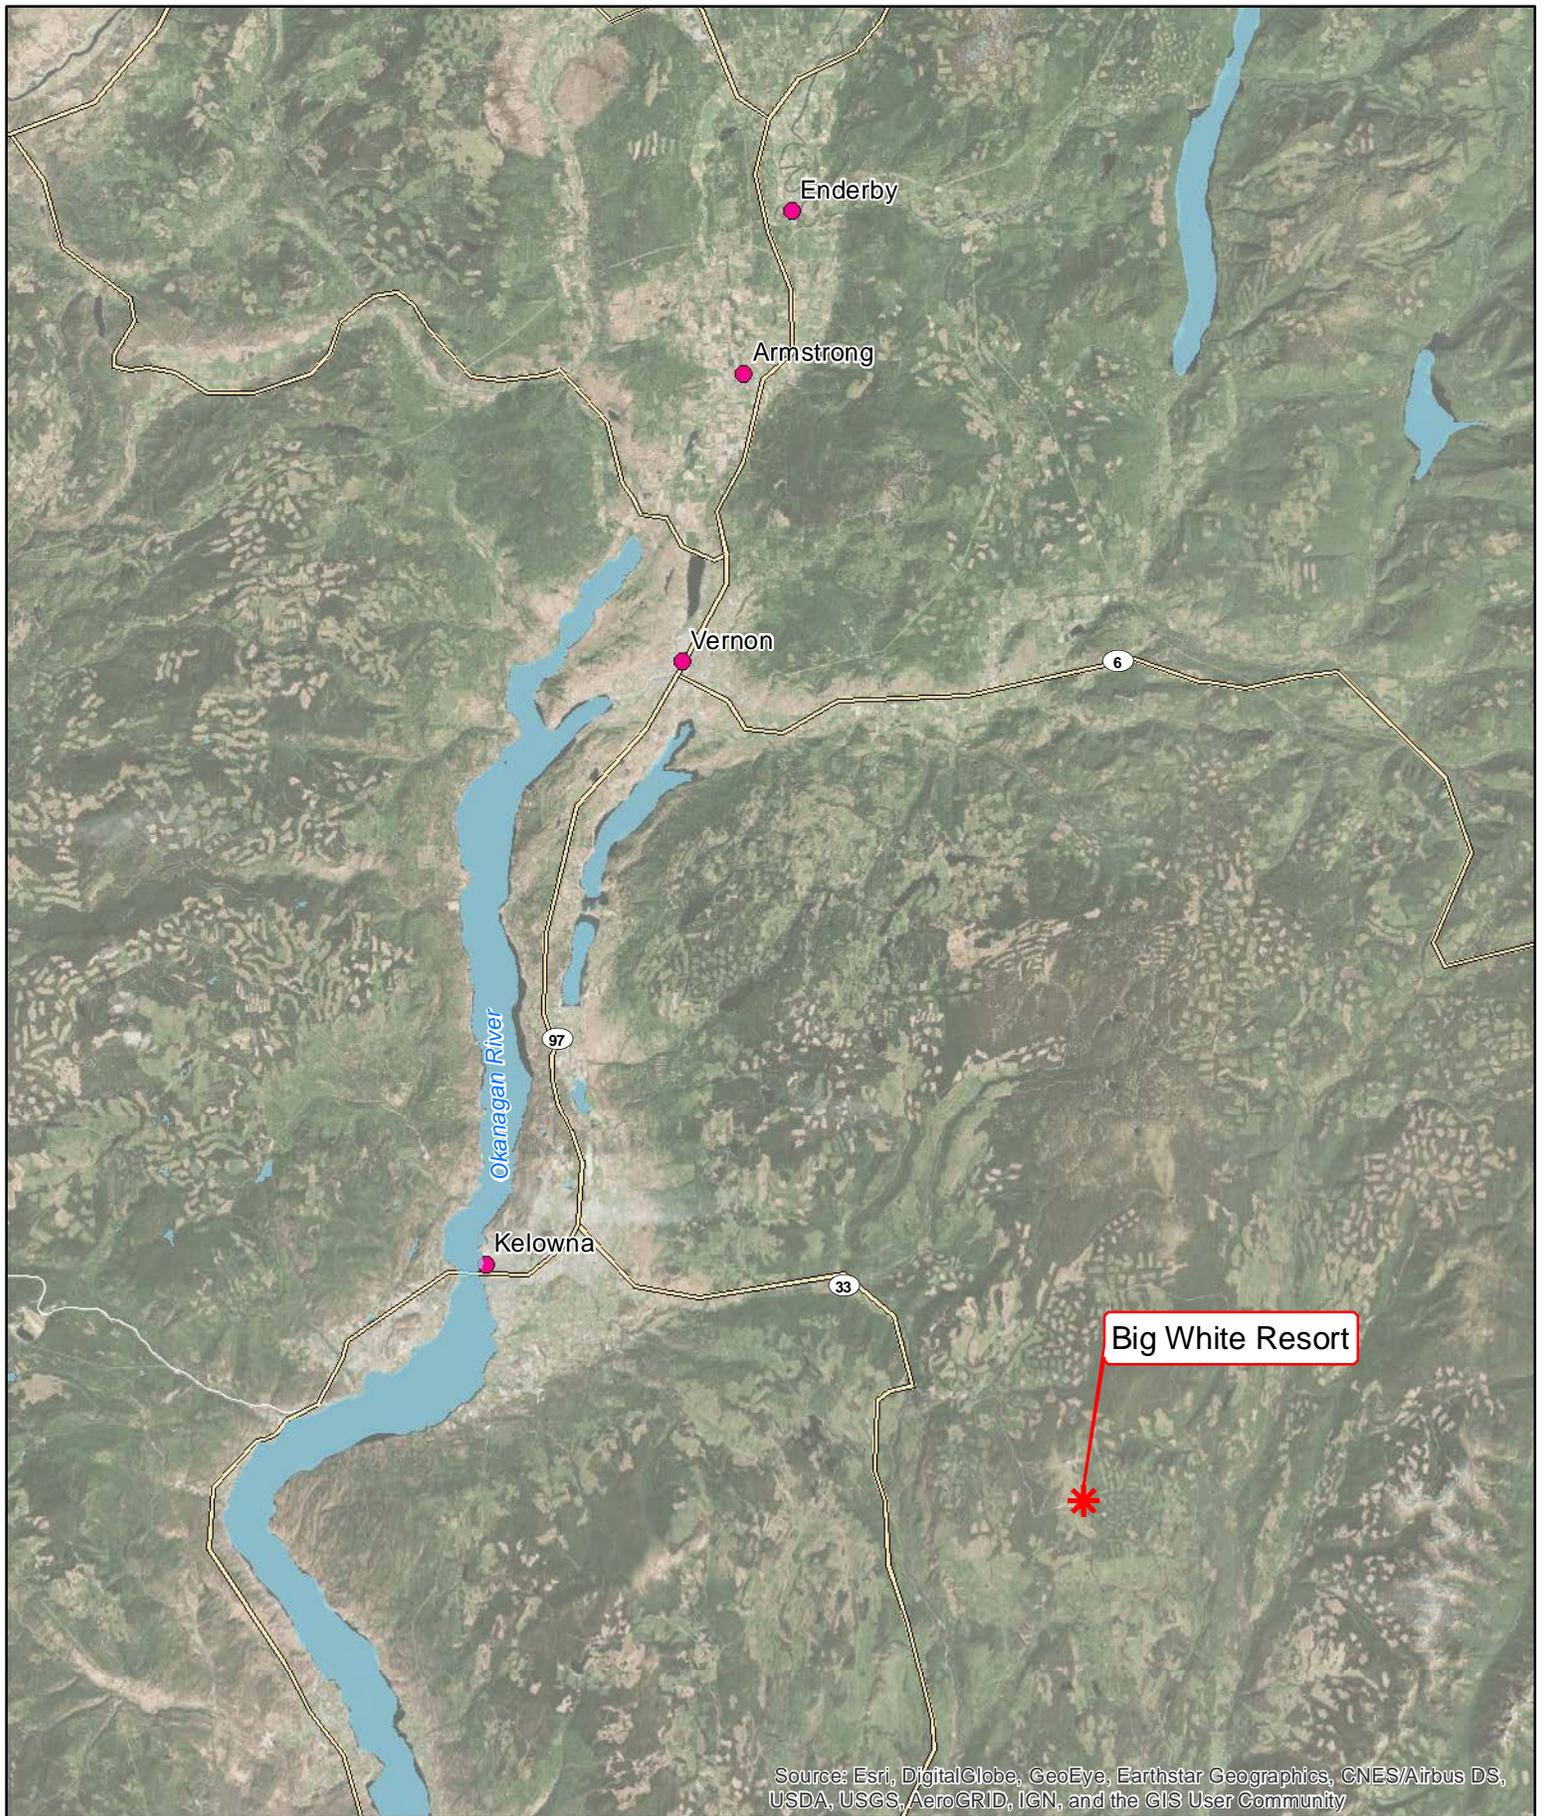
Big White Ski Resort is located in south-central British Columbia, approximately 50 km east of Kelowna (Map 1). The CRA ranges in elevation from approximately 1500 m to 2300 m (Map 2). The CRA is drained to the south by Trapping Creek into West Kettle River, to the west and north by Hallam Creek into West Kettle River, and to the southeast by Whitefoot Creek and Copperkettle Creek. The CRA, the study area which includes the two-chairlift expansion area located in the northeast corner of CRA as well as the drainages are identified on the hydrology map (Map 3).

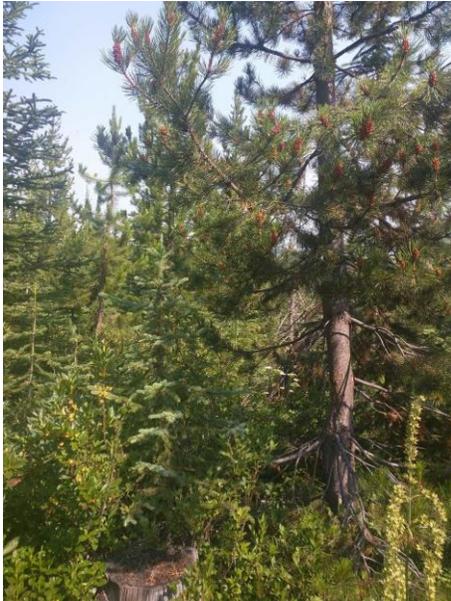
Photo 1: Polygon 1 RV4C vegetation association, August 8, 2018

This polygon represents a pole/sapling coniferous forest recently harvested as a cut block. Soils are poorly drained at a receiving position on the slope with deep and medium textured soils. The tree layer is dominated by subalpine fir with lesser amounts of lodgepole pine. White flowered rhododendron dominates the shrub layer and mountain arnica and Indian hellebore are found within the herb layer. Subalpine firs had an average dbh of 80 mm.

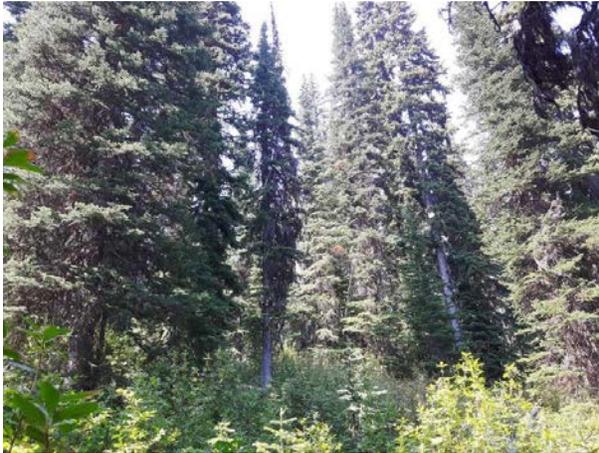
Photo 2: Polygon 2 FR7aC, August 8, 2018.

Polygon 2 TEM CODE DERIVATION			
Decile			
10	FR	7a	a C
100%	104- Bl-Rhododendron – Grouseberry	Old Forest	Coniferous

This Polygon represents an old forest estimated to between 140-250 years old with moderately steep slopes of 40% with sub-mesic to subxeric soil conditions with deep medium textured soils. Subalpine fir dominates the tree cover with lesser amounts of engelmann spruce. The shrub layer is dominated by white flowered rhododendron with lesser amounts of black huckleberry. Herb layer was less developed with minimal occurrence of rattlesnake plantain, queen’s cup and hooker’s fairybells. The average engelmann spruces were measured at a dbh of 513mm with an approximate height of 30 m.

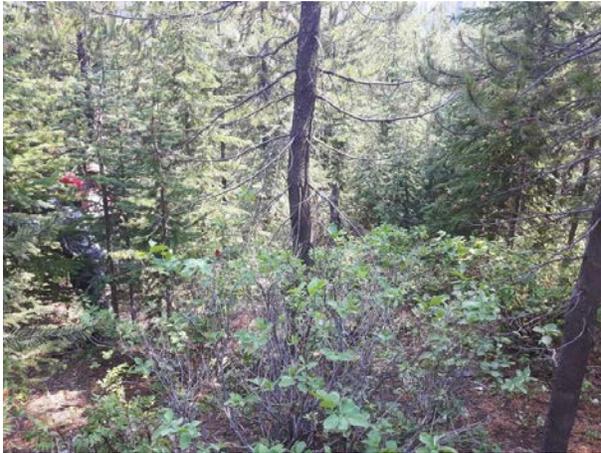
Photo 3: Polygon 3 7FR4C 3RV4C vegetation association, August 8, 2018

Polygon 3 TEM CODE DERIVATION			
Decile			
3	RV	4	C
30%	101- BSeI- Rhododendron – Valerian	Pole/Sapling	Coniferous

Polygon 7FR4C 3RV4C represents a harvested cut block vegetation with a pole/sapling structure with an estimate age of 30 year and stand height of 7 m. Lodgepole pine dominated the tree layer with lesser amounts of Englemann spruce and subalpine fir. Utah honeysuckle dominated the shrub layer with lesser amounts of grouseberry and sticky current. A less developed herb layer was present with a dominant layer of mountain arnica. The site series was in a transition stage between 104 (BI- Rhododendron Grouseberry) and 101 (BISe-Rhododendron – Valerian) with deep and medium textured soils.

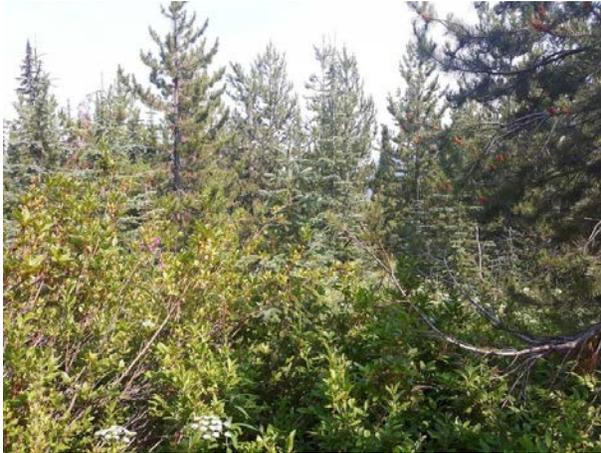
Photo 4: Polygon 4 5RV4C 5FG4C, August 8, 2018.

Polygon 4 TEM CODE DERIVATION			
Decile			
5	FG	4	C
50%	103 –BIPI Falsebox- Grouseberry	Pole/Sapling	Coniferous

This polygon represents a recently harvested cutblock with a pole sapling structural stage. Lodgepole pine is the dominant tree, white flowered rhododendron is dominant within the shrub layer and Indian hellabore, arctic lupine and hookers fairybells is present within the herb layer. Due to drier characteristics and dominant presence of lodgepole pine and arctic lupine and the dominant shrub layer of white-flowered rhododendron the polygon was characterised as a transition stage between site series 101 and 103.

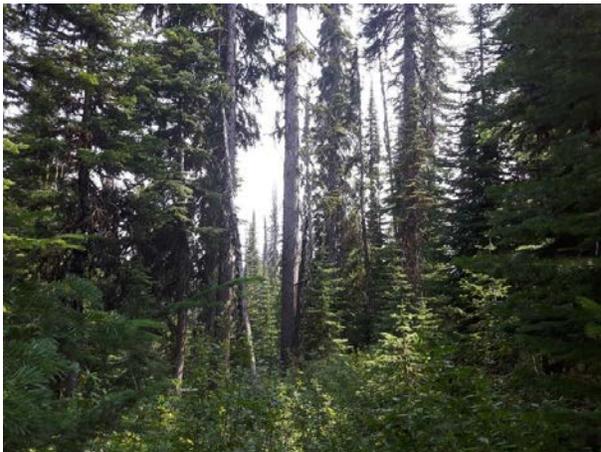
Photo 5: Polygon 5 RV7aC vegetation associations, August 8, 2018.

Polygon 5 TEM CODE DERIVATION						
Decile						
10	RV		7a	a	C	
100%	101- BISe- Rhododendron – Valerian		Old forest		Coniferous

Polygon 5 shared the same soil and vegetation associations with polygon 1 RV4C except the forest structural stage was found to be in an old forest structural stage without recent disturbance. Stand age was estimated to be 200 years or more with an estimated height of 20 m.

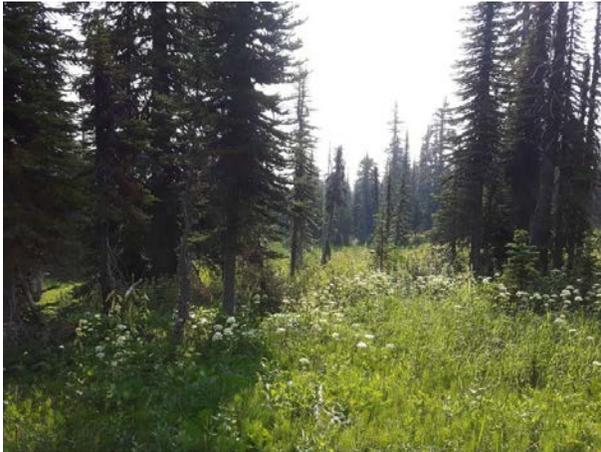
Photo 6: Polygon 6 FH7aC vegetation association, August 9, 2018.

Polygon 6 TEM CODE DERIVATION			
Decile			
10	FH	7a	a C
100%	112- Se-Horetail-Globeflower	Old forest	Coniferous

Polygon 6 FH7aC represents deep hygric soils with a high water table found in level areas on the outflow below Rhonda Lake. Vegetation included engelmann spruce and subalpine fir on raised microtopography with a well developed herb layer dominated with horsetail and lesser amounts of Indian hellebore and arrow leaved groundsel with a 30 % spagnum moss coverage within the site.

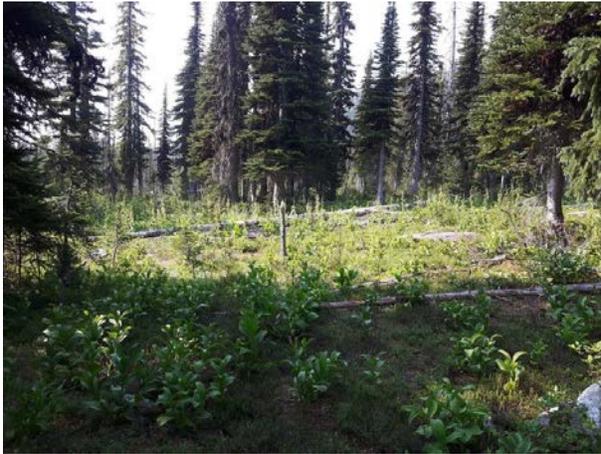
Photo 7: 5RV7aC 5FT7aC, August 9, 2018.

Polygon 7 TEM CODE DERIVATION			
Decile			
5	FT	7a	a
50%	110- BISe- Rhododendron - Hellebore	Old Forest	Coniferous

This polygon is represented by gentler slopes in the higher alpine producing a 110 BISe-Rhododendron-Hellebore series with a forested alpine meadow with a tree cover of 10 % including Engelmann spruce and subalpine fir. The shrub layer is dominated by heather and grouseberry and herb layer mainly dominated by Indian hellebore. As the polygon slopes percentage increases and soils become coarser 101 BISe- Rhododendron -Valerian site series is represented.

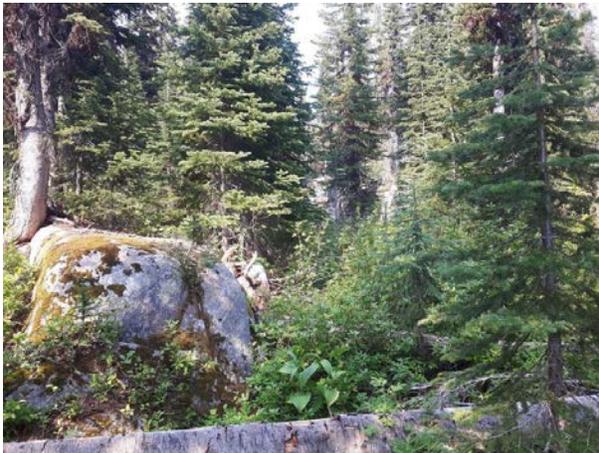
Photo 8: Polygon 8 5RV7aC 5FG7aC, August 9, 2018.

Polygon 4 TEM CODE DERIVATION			
Decile			
5	FG	7a	a
50%	103 – Grouseberry - Cladonia	Old forest	Coniferous

This polygon shares similar vegetation and soil characteristics as Polygon 4 5RV4C 5FG4C, however, the structural stage was to be found as old forest with a stand age of approximately 200 years and a stand height of 25 m. Areas of this polygon were observed with steep slopes, rocky outcrops and subxeric soils producing the 103 (BIPI - Falsebox – Grouseberry) vegetation associations.
