TERRAIN STABILITY ASSESSMENT

**Big White Ski Resort
Backcountry &
Black Forest Chair Expansion**

Whitefoot Creek

Subject: **Terrain Stability Assessment of
Big White Ski Resort Backcountry and Black Forest Chair Expansion**

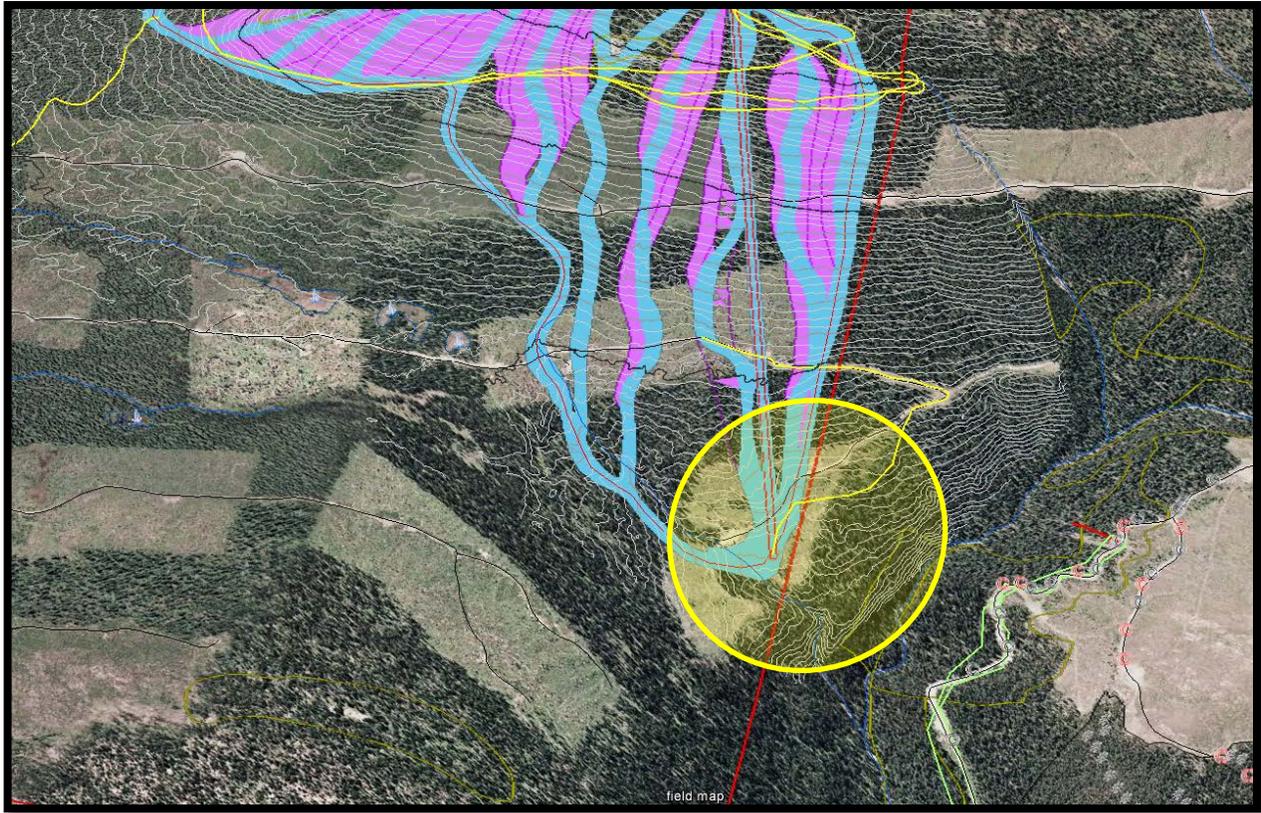
Image 1: Orthomosaic view of proposed development area looking to the west.
Area of concern outlined in yellow.

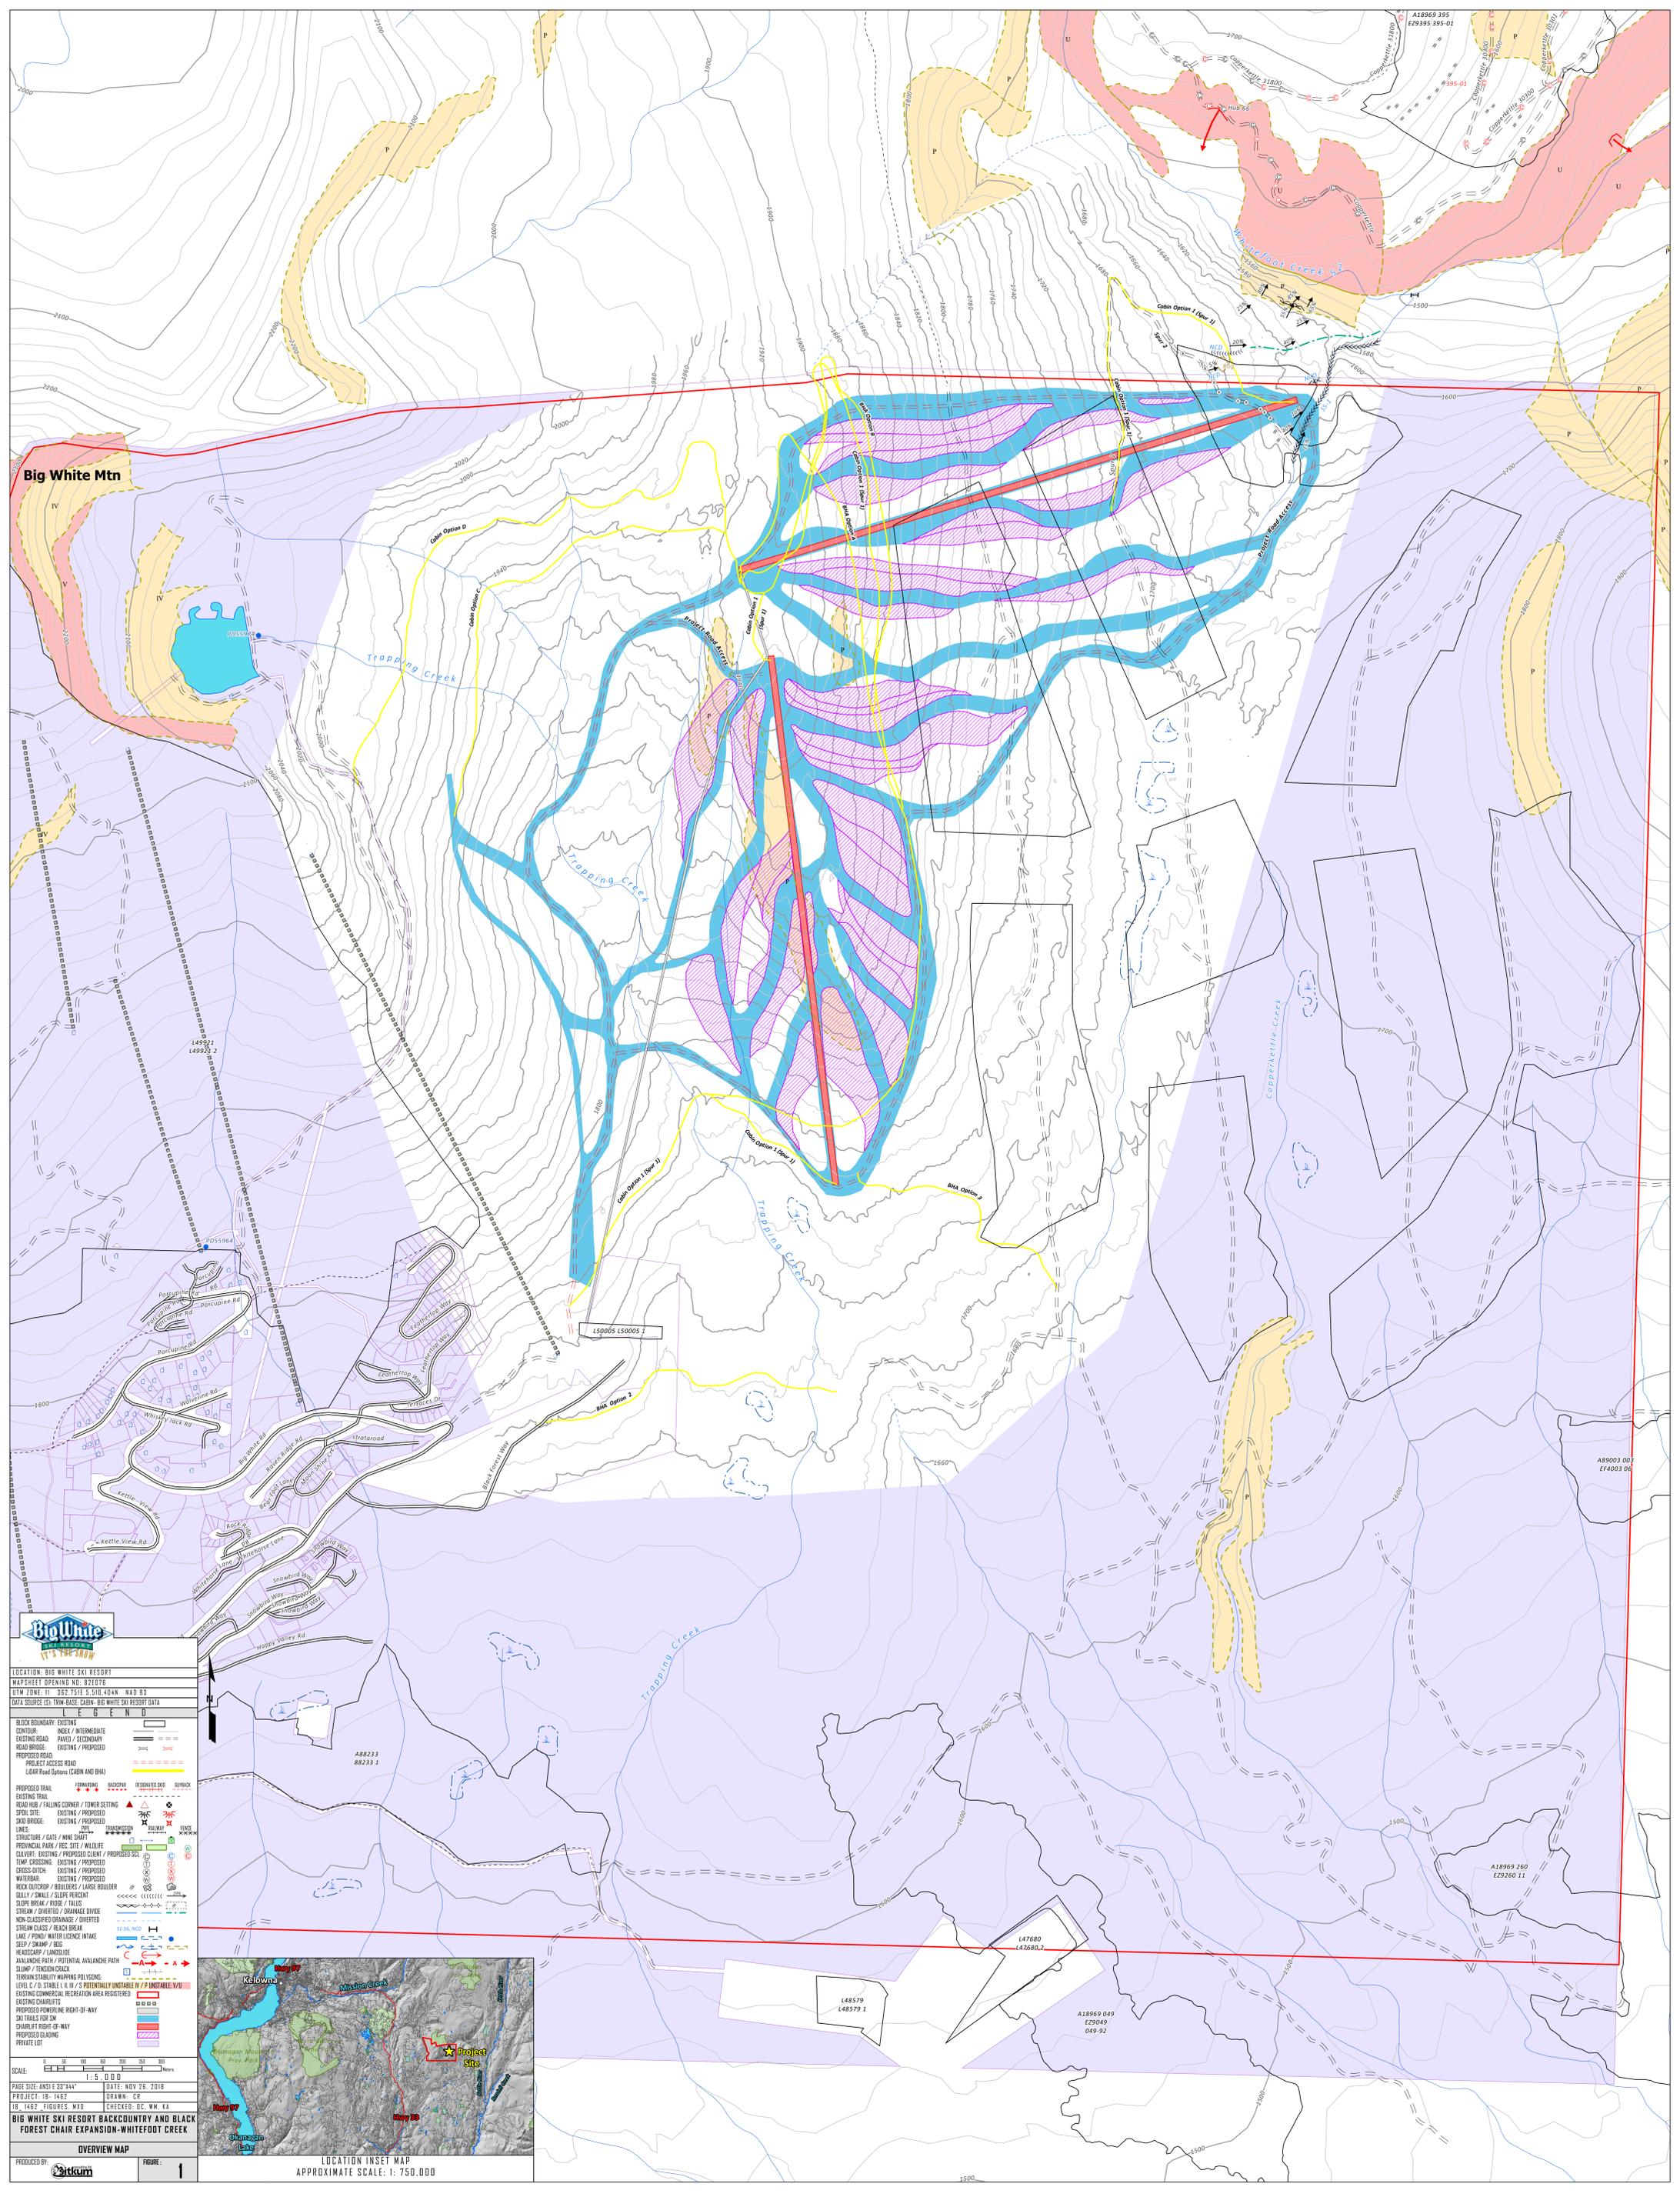
FIGURE: 1

Based on an office review by Mr. Wayne Miller, P.Geo, Eng.L. of SCL prior to the field assessment, it was determined that the majority of the proposed Big White expansion is situated on benign terrain with a Very Low likelihood of slope instabilities (Figure 1). There are three terrain polygons mapped as potentially unstable (P) in the western portion of the development near the proposed southern ski lift and east of Trapping Creek. These areas are more likely to be classified as stable (Very Low likelihood of slope instability) due to the predominately flat to moderate gradient; there are isolated areas of irregular, steeper terrain within and immediately downslope of the P polygons that are short (<50 m) and consist of localized exposed bedrock and

Based on the referenced SCL Report 15-1107 dated December 9, 2015, two debris slides were observed along the north gully sidewall of Whitefoot Creek (Figure 1). The first slide headscarp was noted ~190 m downslope of the junction of Copperkettle FSR and Copperkettle 30300 on an imperfectly drained slope of 70%. This slide was estimated to be >70 years old, ~60 m long and likely impacted Whitefoot Creek. The second slide was located... *'immediately downslope of the culvert at Hub 66 of existing Copperkettle FSR. The cause was likely road drainage related*
